# Watershed Management Techniques for Brook Trout Habitat Improvement, Lake Superior South-Shore Streams, Wis.

## OVERVIEW

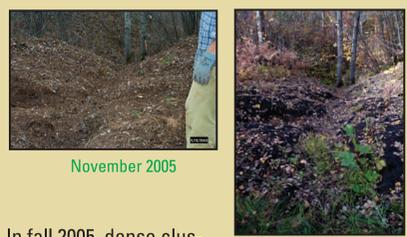
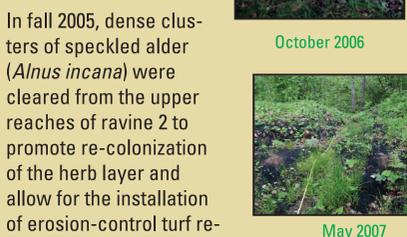
### Vegetation/Planting

In fall 2005, dense clusters of speckled alder (*Alnus incana*) were cleared from the upper reaches of ravine 2 to promote re-colonization of the herb layer and allow for the installation of erosion-control turf reinforcement mats. Some trees and snags were removed to relieve long-term pressure on highly erodible banks. In 2006, three native sedge species (*Carex* spp.) were planted in and around the stabilized erosion control mat and other physical controls, and on actively eroding sand banks. Sedges planted in the spring of 2007, in the sand banks, are expected to stabilize the sand bank as well as the deposited channel sediments.

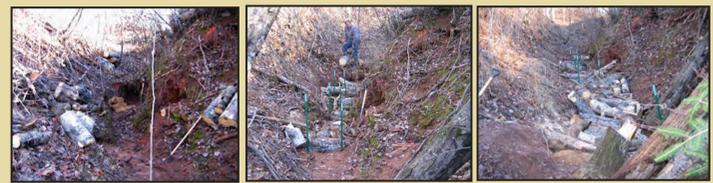
### Physical Measures

A variety of physical measures were utilized in fall 2005 to slow runoff velocities, stabilize existing soil layers, and promote sediment deposition. These measures utilized locally available materials, for brush bundles and coarse woody debris structures, in addition to biologs, sandbags, and erosion-control mats. Eroding head-cuts, deeply incising ravine reaches, eroding sand banks, and areas of high potential energy received a combination of the above treatments.

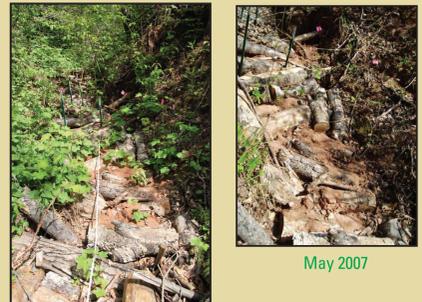
The area shown below was treated in fall 2005 with a combination of physical and biological measures. Armoring reduced incision in the channel and stabilized eroding sand banks. Increased roughness slowed runoff velocities and had promoted sand deposition by May 2007.
