Changing Perspectives for Monitoring Stream Restoration Success ---Sediment---

Faith A. Fitzpatrick and Marie C. Peppler

U.S. Geological Survey, WI Water Science Center, Middleton, WI

Upper Midwest Stream Restoration Symposium, La Crosse, WI, Feb. 21-23, 2010

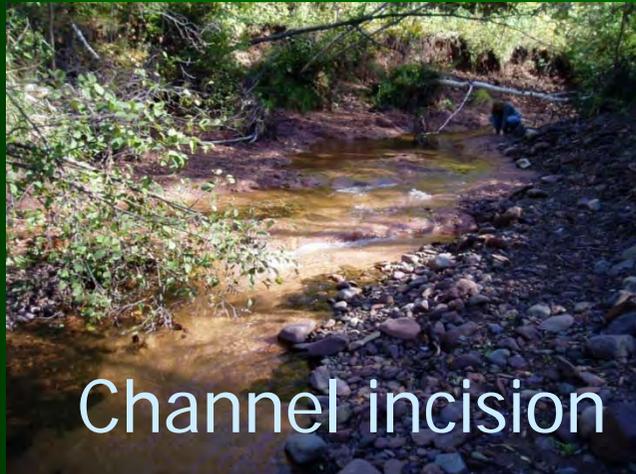
Channel incision

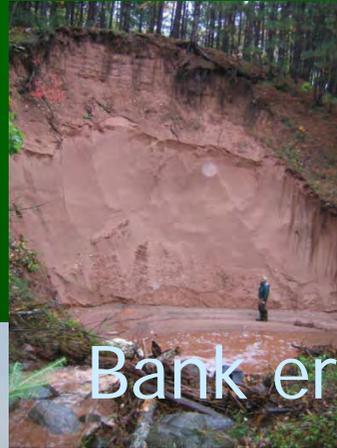
Bank erosion

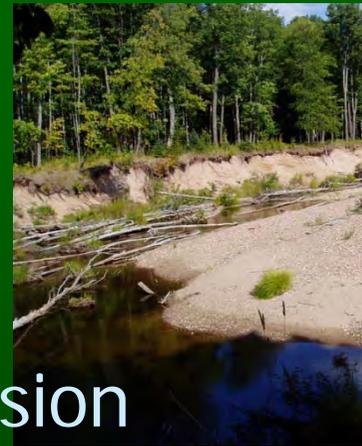
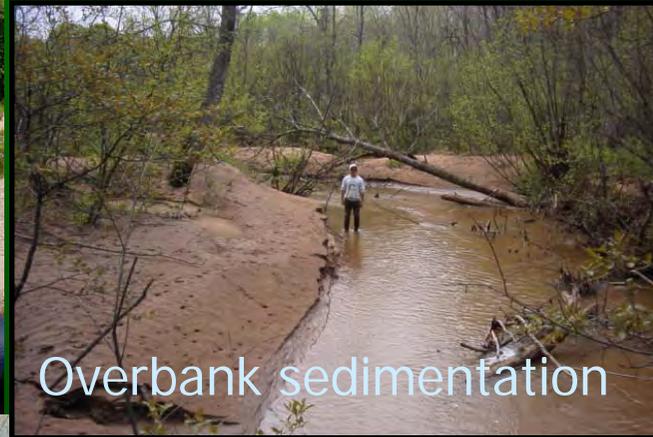
Overbank sedimentation

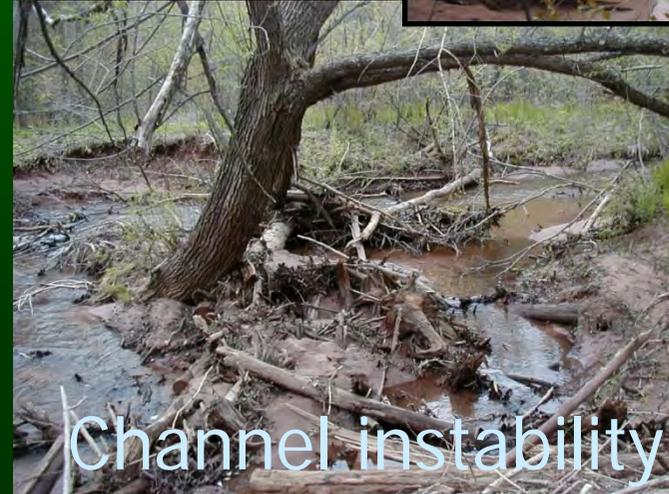
Channel instability

Whittlesey Creek Erosion Hot Spots along upper main stem = > 90% sediment load from channel sources

- Eroding valley side or terrace—
Entrenched or confined valley
- Eroding bank
- Stabilized bluff or bank

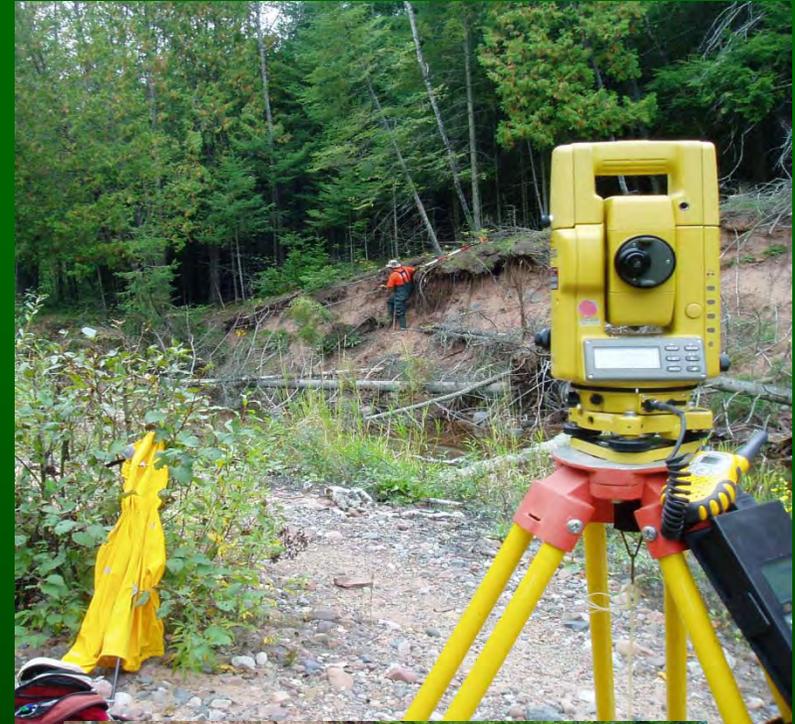
Site 16.4

North Fish Creek bluff stabilization (2000-2010)

Repeat cross section surveys

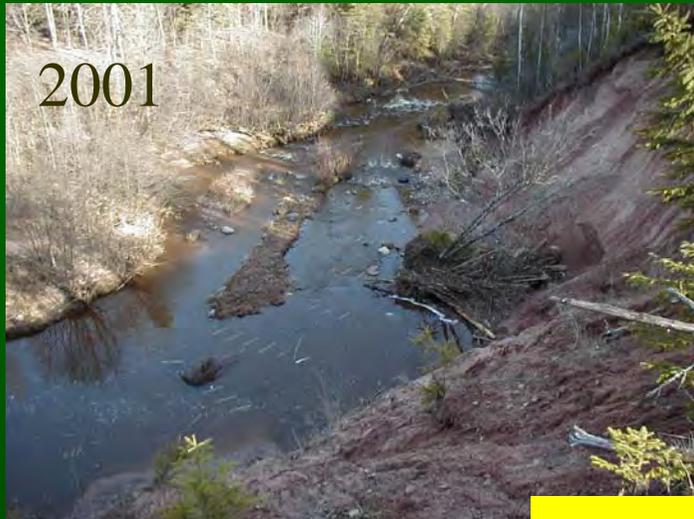
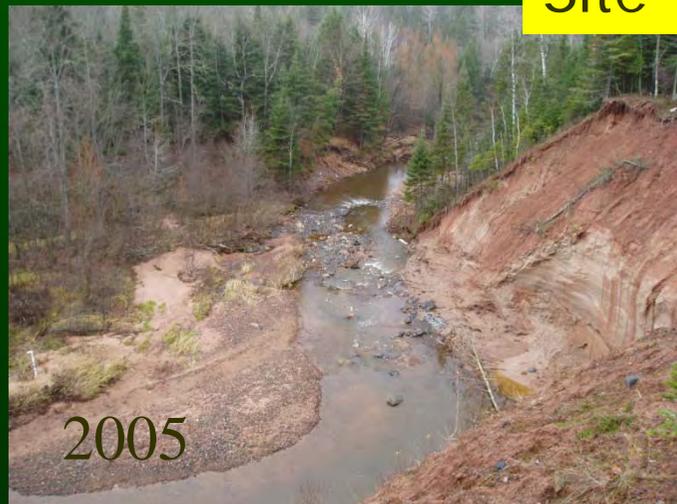
Site 16.4

North Fish Creek bluff stabilization

Photo points are qualitative but convey powerful message of success or failure

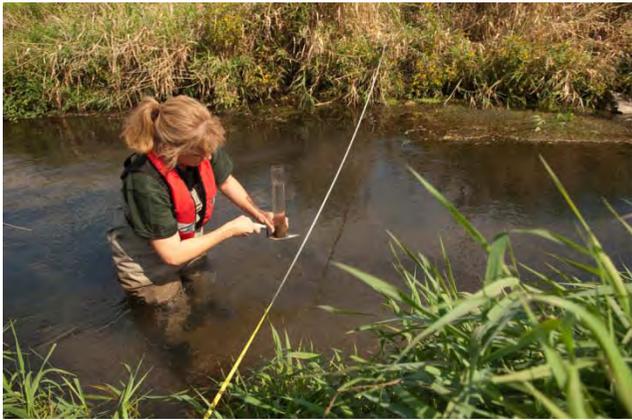
Soft fine-grained sediment
"savings and loan"
